Work Methods Bulletin

A Publication of PPL EU Technical Development & Communication

Date: 30-Dec-14

480V Delta Transformer Banks

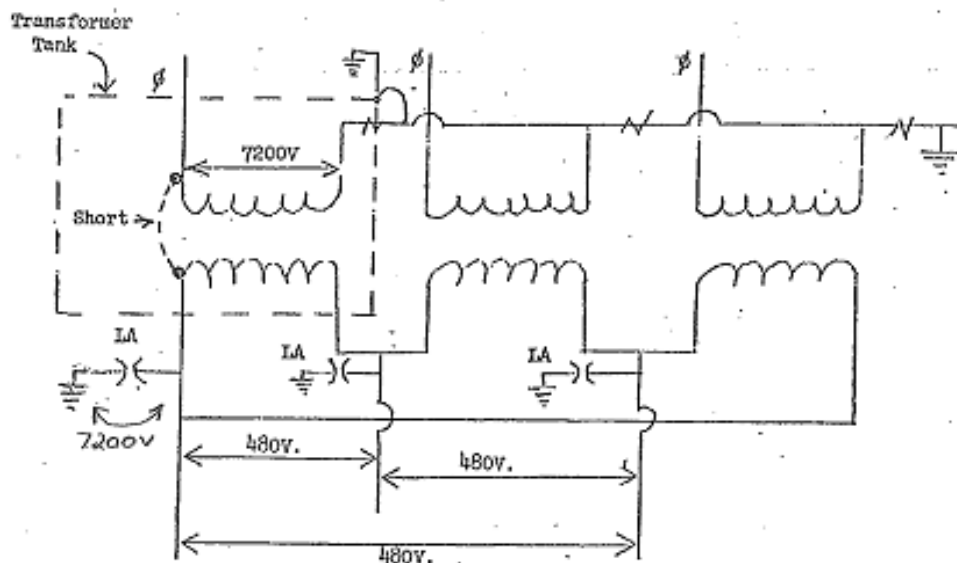
Transformer testing indicated one of the transformers in the ungrounded Delta bank had a winding failure from the primary to secondary winding. The 7,200 volt transformer winding was shorted to the 480V winding in one of the three transformers. The winding was not shorted to the transformer tank.

High voltage was present on one leg of the 480V service with respect to ground. Since the 480V service is ungrounded, this condition persisted until the Tegam voltmeter was applied to the customer's breaker within a grounded enclosure. The enclosure had tight clearances, resulting in a strong primary voltage electrical field. Applying the meter to the circuit breaker lugs within the grounded enclosure disturbed this strong field, triggering an arc. Once started, the electrical arc spread to all three phases within the enclosure. The arc was quickly extinguished by the operation of an upstream recloser.

Below is a diagram of the 480V Delta transformer configuration, showing the voltages that are present during this type of winding fault:

- A 480V Delta service should never be energized without a secondary lightning arrester in place. When the arrester is removed from the secondary side for transformer troubleshooting, the transformer leads and service must be disconnected from the transformers. Temporary neutral connections must then be installed on the transformer secondary bushings before energizing the transformer(s) during troubleshooting. See DDI L-361 sections 5.1.2 and 5.7 and DDI L-364 sections 5.1, 5.2.5, and 5.2.6.
