Safety Alert

Snaphook Failure

PRODUCT NOTICE — SNAPHOOKS

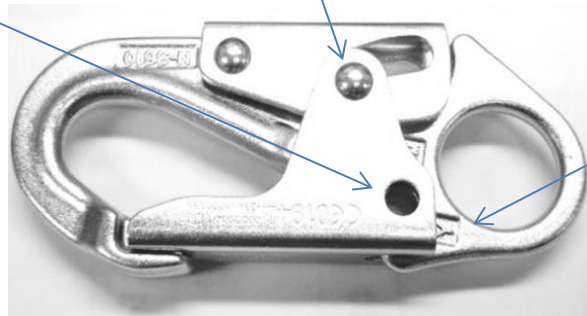
Capital Safety is aware of an assembly issue with snaphooks manufactured by a supplier. These snaphooks are widely used components in fall protection products. The issue concerns missing or improperly installed rivets (see photograph below). The manufacturer symbol is a stamped “Y” as shown in the photograph.

Example of missing rivet

Rivet in place

“Y” symbol

The picture above is a representative model snaphook – other models are also affected.

We want to remind users to conduct a pre-use inspection of all fall protection safety equipment prior to use as per instructions in the user manuals. If a missing or incompletely installed rivet is identified in a snaphook on a Capital Safety product, the product should be removed from service, tagged with a defective tag and returned to Tool Facility at the SFC for collection. They will then be sent for replacement under warranty. (See figure 1 & 2 below.)

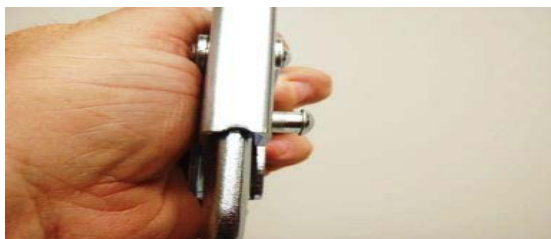
Figure 1: Loose rivet may protrude from hook.

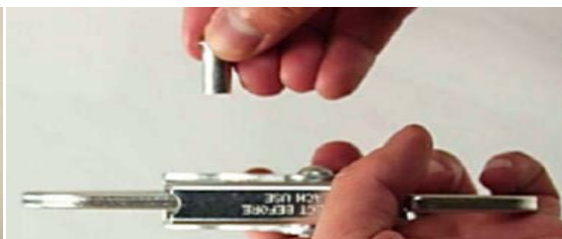
Figure 2: Loose rivet can separate from hook
